NARKOMED 6000
TECHNICAL SERVICE BULLETIN # 6002

Product: **Narkomed 6000**

Date: October 30, 2000

Re: **Vitalbus Hub J-13 connector orientation**

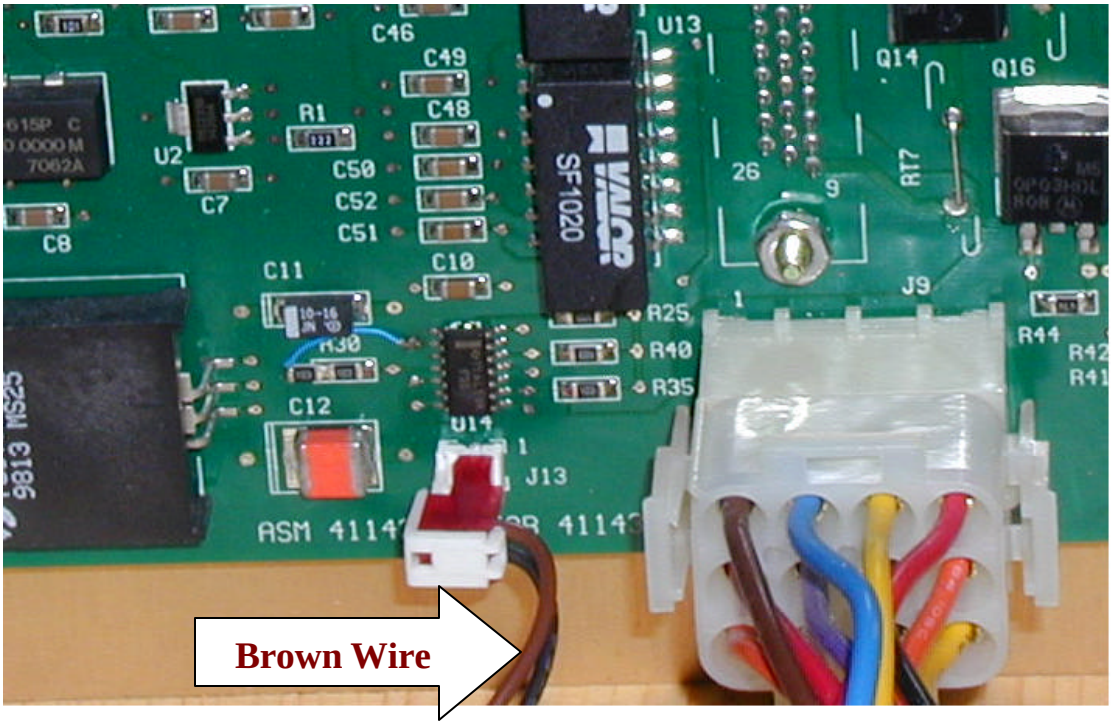
Figure-1 Vitalbus HUB J-13 Connector Orientation

Reason/Rational: To ensure proper installation of the small 2-pin wire harness at J-13 of the Vitalbus Hub PCB after repair or service work is performed. Incorrect orientation of this polarity sensitive cable will cause a system failure that may not be immediately recognized.

Solution/Procedure: When re-attaching the 2-pin wire harness to Vitalbus HUB at J-13, verify it's proper orientation. From the header connector the lead wires must route to the right and the brown wire must positioned above the black wire. See attached illustration Figure 1. Also refer to Narkomed 6000 Technical Service manual Replacement Procedures, Section - 4 for complete servicing instructions.
